900 S. Des Plaines Ave. Forest Park, IL 60130. Tel: 773-594-1451, Fax: 773-594-0583 www.csosinc.com

Object: General Tadeusz Kosciuszko, 1905.
Artist: Gastano Trentanove
Material: Bronze, Granite.
Owner: City of Milwaukee
Examined: 2008

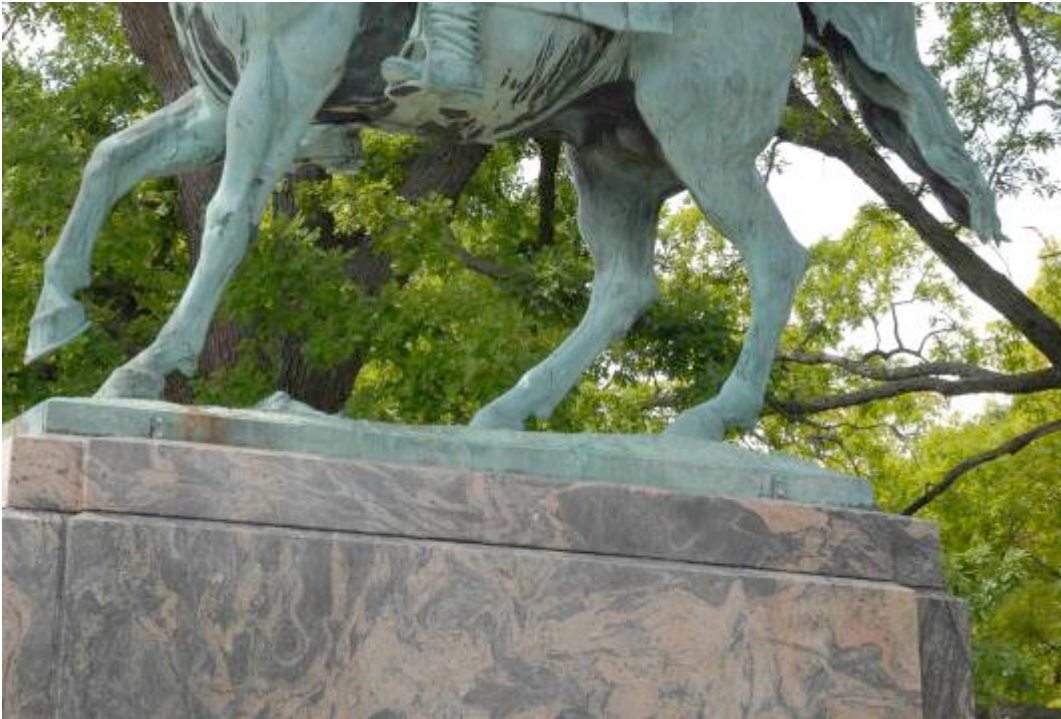
Fig. 1. Proper left side view. The entire surface is corroded - disfiguring green, and black streaking. Please notice the two brackets attaching the base of the bronze to the stone. Please also notice the rusty stain at the front of the bronze base.

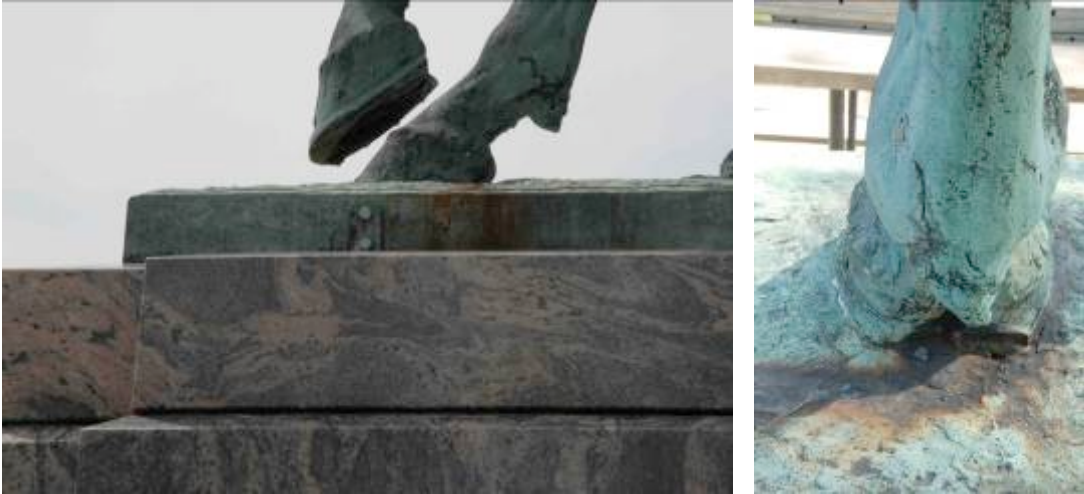
Fig. 2. Detail of the proper left side of the base - showing the bracket, and iron stain leaching out from the inside of the horses leg.

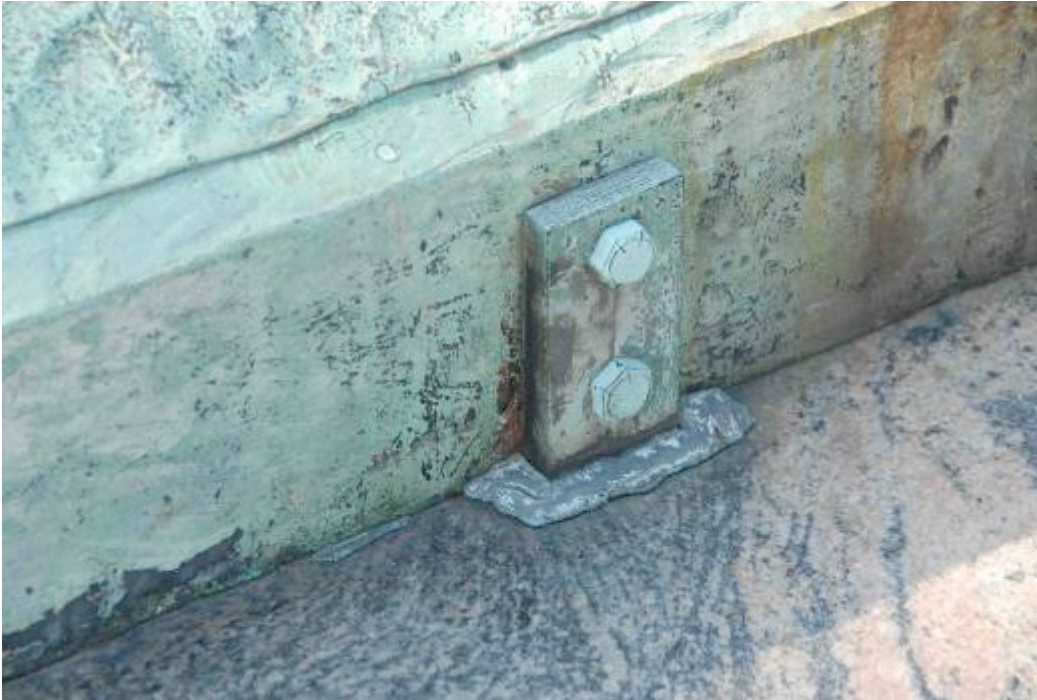
Fig. 3. Bracket attaching the sculpture to the pedestal. There are 4 mounting brackets holding the base of the sculpture to the pedestal.

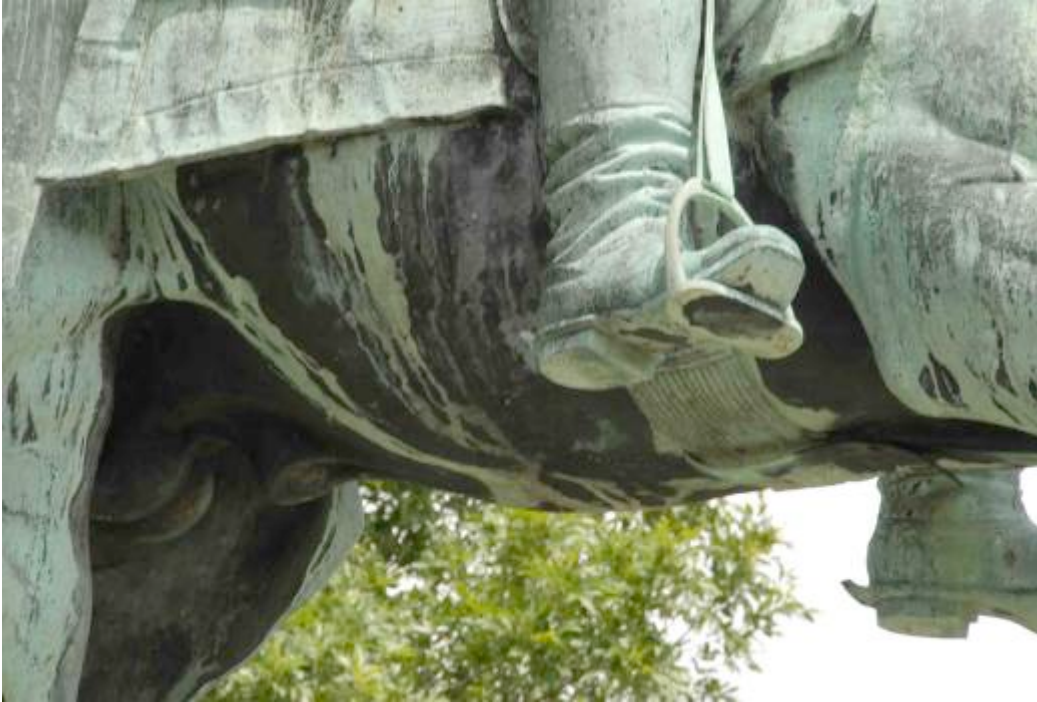
Fig. 4. Detail of the proper right side - showing very unevenly corroded surface of the bronze. The streaking seriously disfigures the aesthetical design of the sculpture.

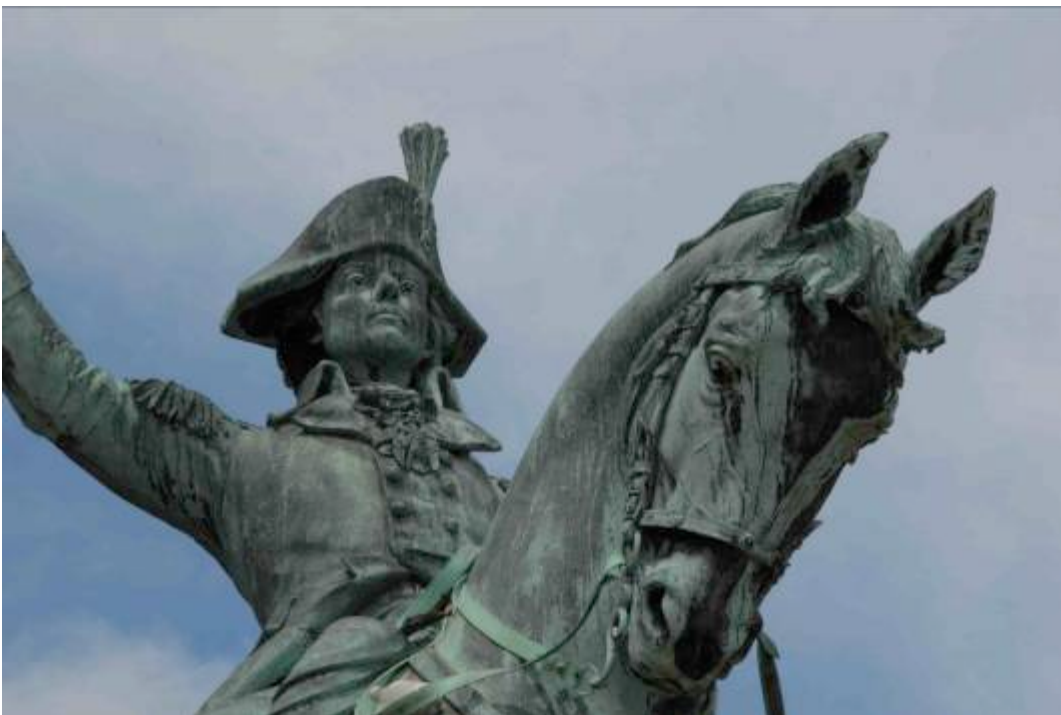
Fig. 5. Detail of the upper section of the sculpture - showing streaking at the head of the horse, and the face and hat of Kosciuszko.

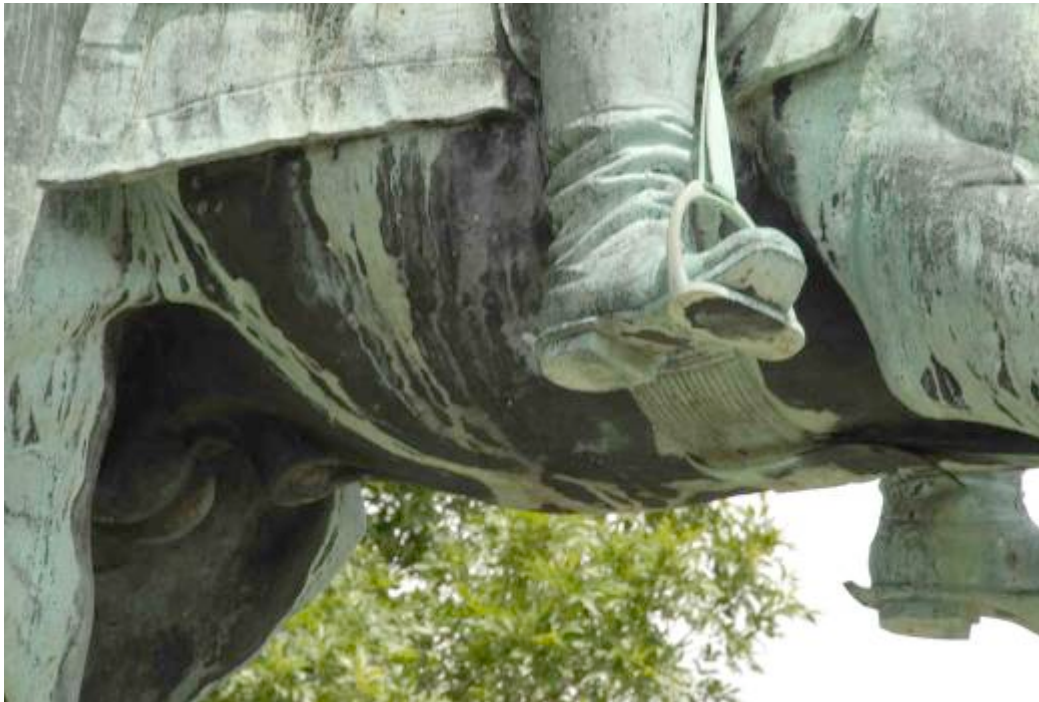
Fig 6. Detail of the belly of the horse - showing severe streaking, and missing both spurs.

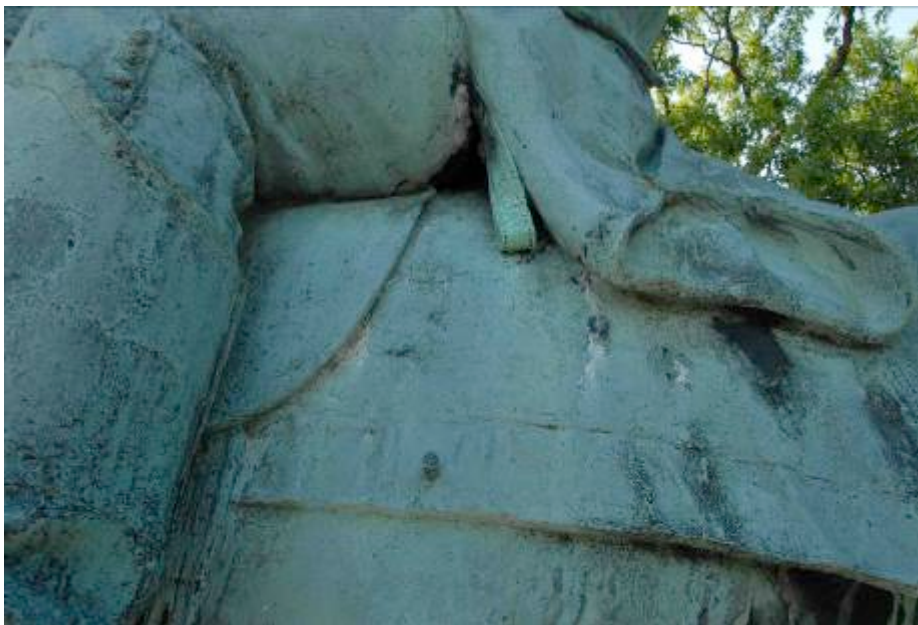
Fig. 7. Detail of the proper left side of the sculpture. Please notice the unevenly corroded surface, and white material leaching from the joints. The

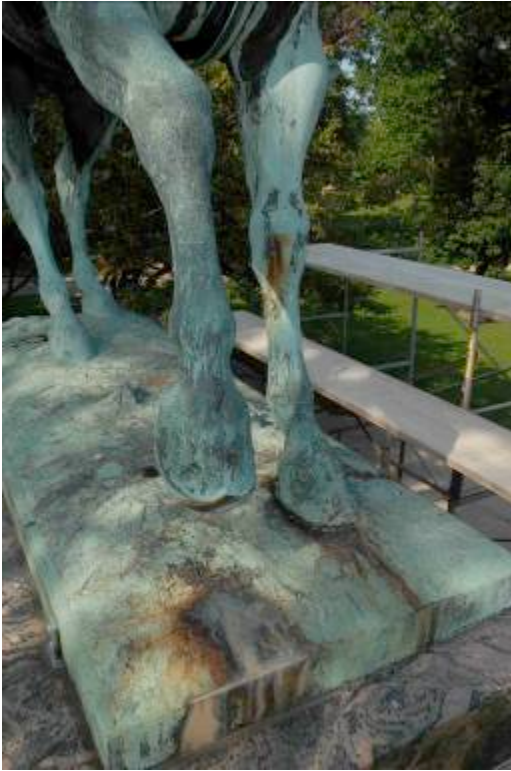
Fig. 8. Front view. Please notice severe streaking, iron stains at the proper left knee of the horse, iron staining the base at the bottom of the proper left leg, and iron staining the base under proper right leg of the horse (raised up). It appears that the armature inside of the sculpture is severely corroded. It is very probable that the armature does not support the sculpture anymore. The amount of iron staining indicates that the problem is very serious. The sculpture should be further examined internally for redesigning structural support which might be necessary.

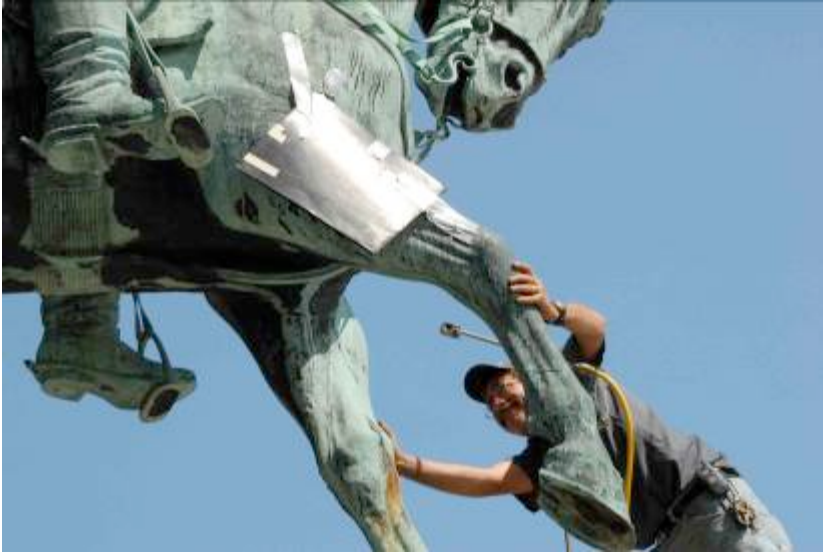
Fig. 9. Picture illustrating x-ray analysis of the sculpture.

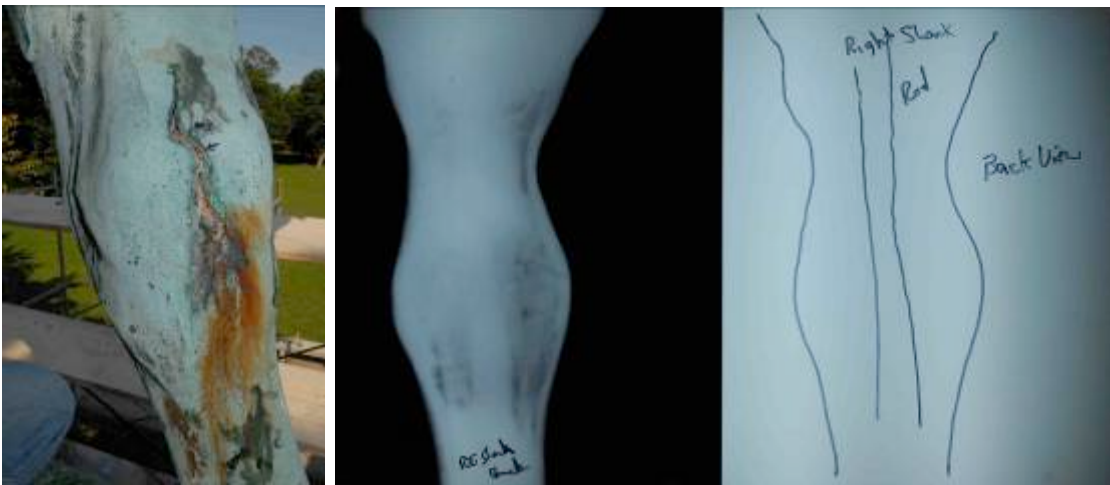
Fig. 10. Detail of the proper left front leg of the horse. The image on the left illustrates external structural problems caused by deterioration of the internal ferrous armature and concrete fill. The white seen inside the leg was proved to be concrete (MVA analysis – see attached report). The material deposited under the crack is rusty in color and comes from decomposing ferrous reinforcement clearly visible in the x-ray image in the middle and drawing on the right. This long crack was created by freeze and thaw cycles, expansion of deteriorated concrete material and expansion of ferrous corrosion products. Iron corrosion products and core material leach out.

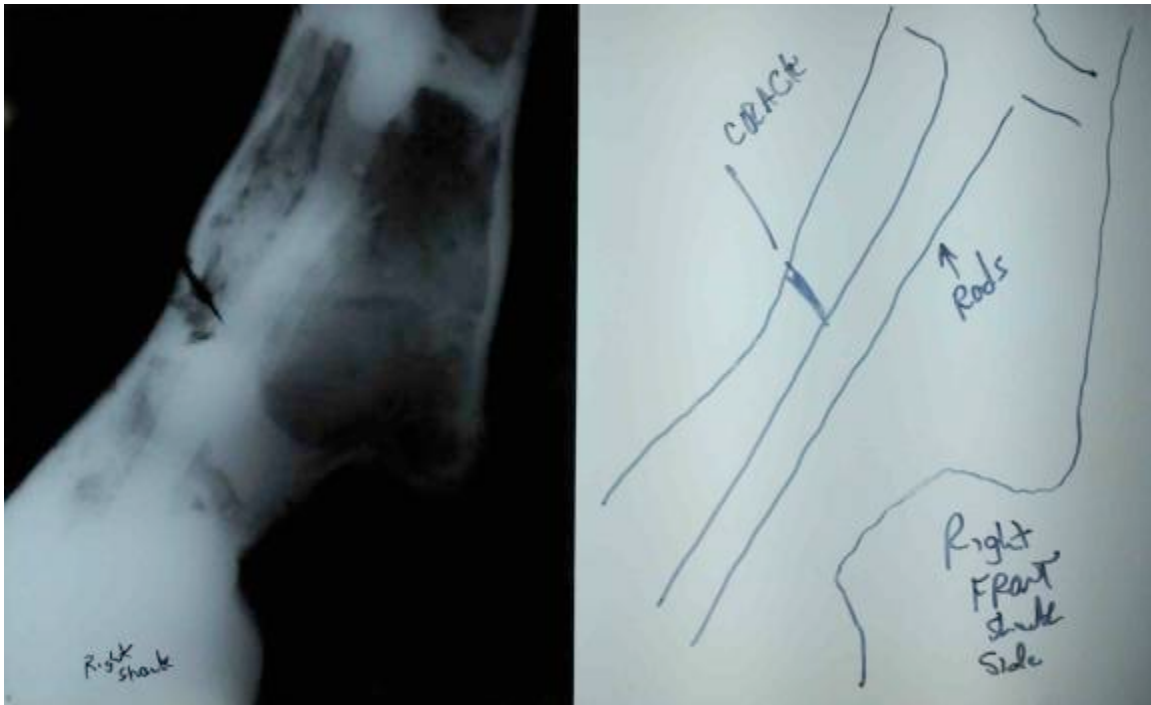
Fig. 11. This x-ray image clearly illustrates cracking of the bronze and presence of ferrous rods in the proper front left leg. (Incorrectly labeled as right leg by x-ray technician.)

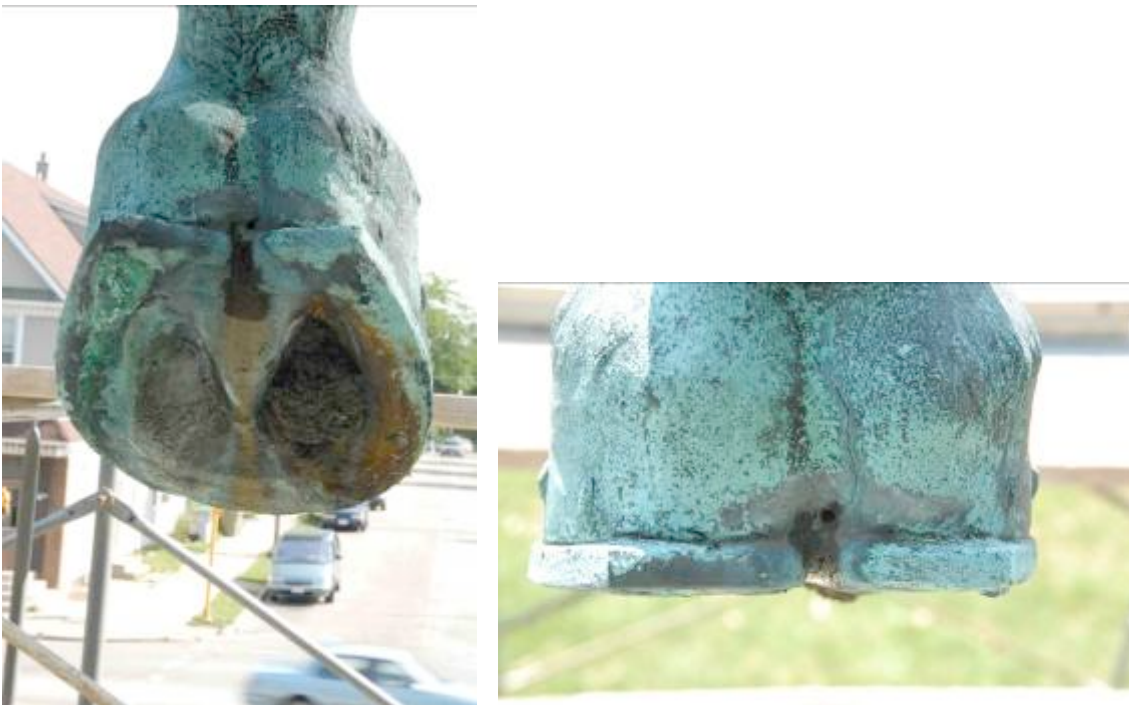
Fig. 12. Images illustrating external condition of proper right hoof. There is a thick layer of deposited material that leached out from the inside of the sculpture.

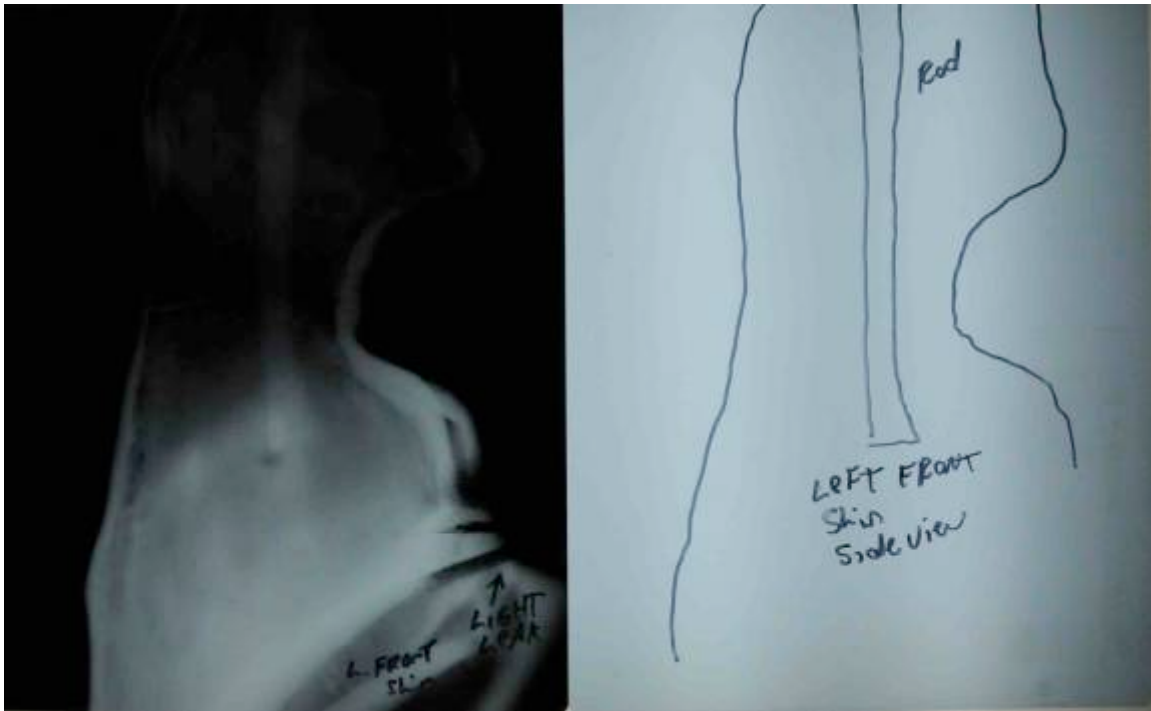
Fig. 13. X-ray image illustrating presence of internal armature. X-ray analysis and analysis of samples performed by MVA strongly suggest that the armature is made of ferrous material. (Incorrectly labeled as left leg by x-ray technician.)

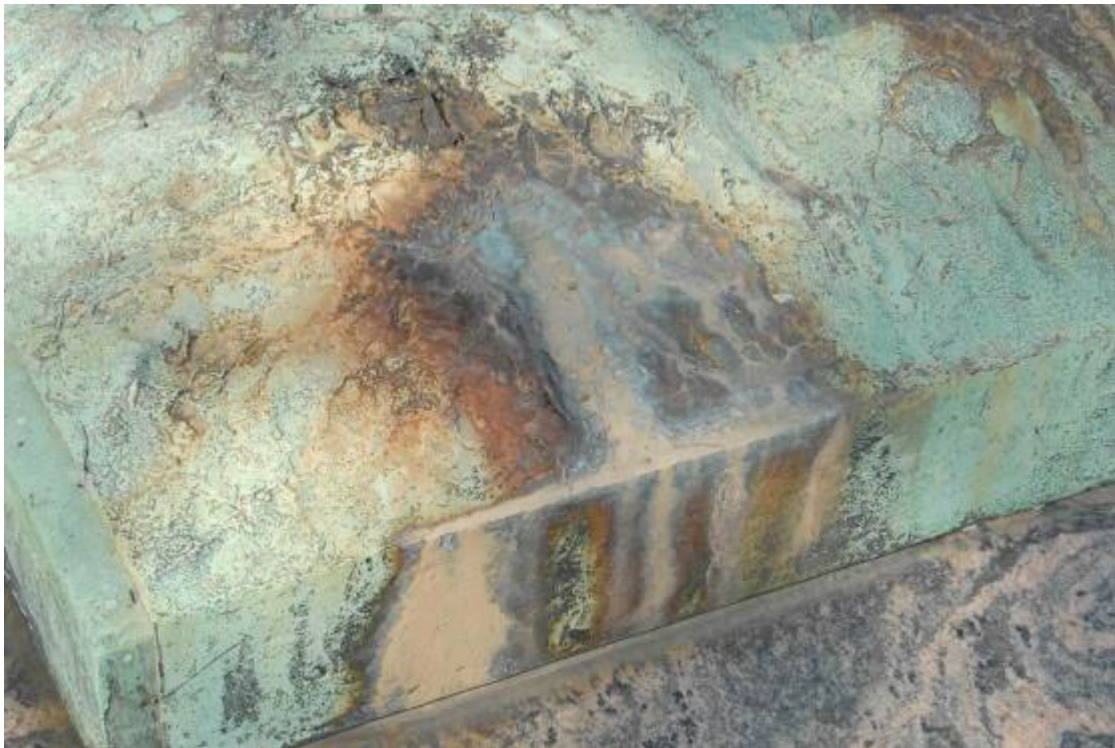
Fig. 14. Front of the bronze base. Please notice iron staining of the surface running from the proper right front leg of the horse.

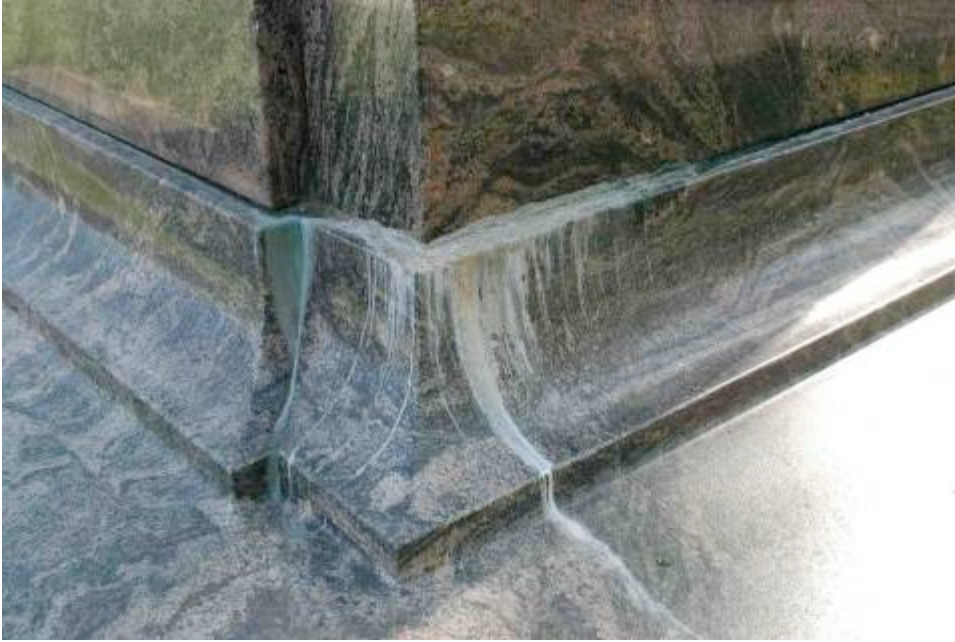
Fig. 15. Detail of the proper left side of the back of the base. Please see leaching white material from the joint, and graffiti on the horizontal surface. The white material has green tint, which indicates that there is a failed joint between stones at the upper section where the bronze rests. Green indicates presence of copper corrosion in the deposit.

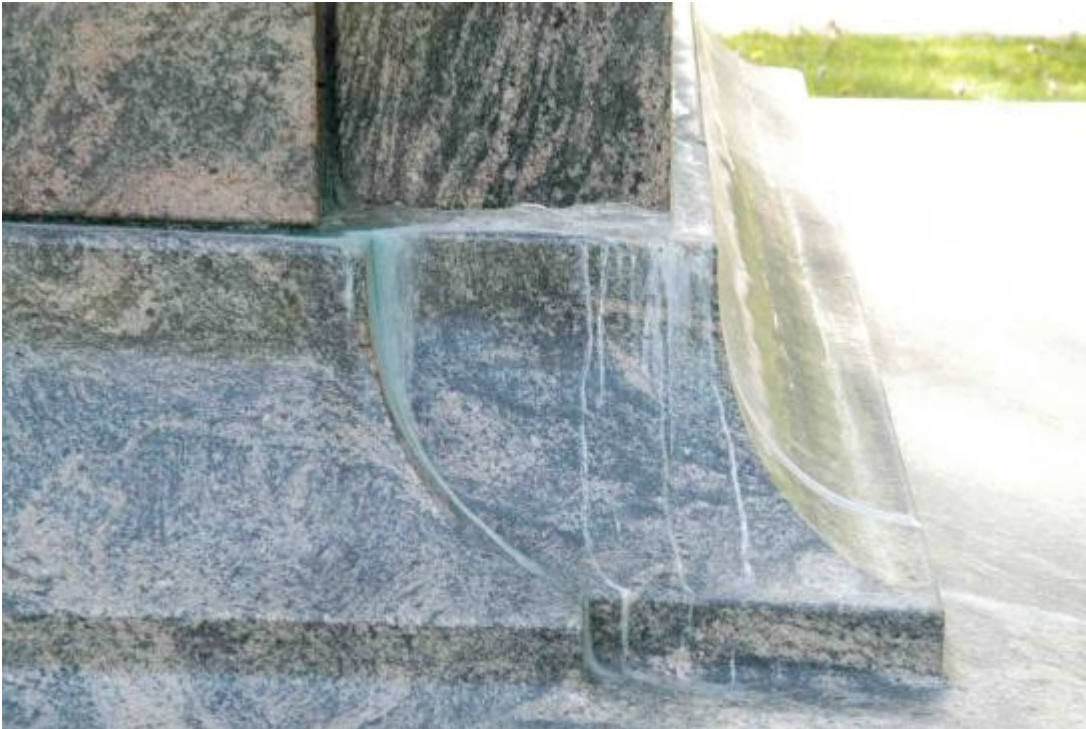
Fig. 16. Detail of the proper right side of the back of the base. Please see leaching white material from the joint, and graffiti on the horizontal surface.

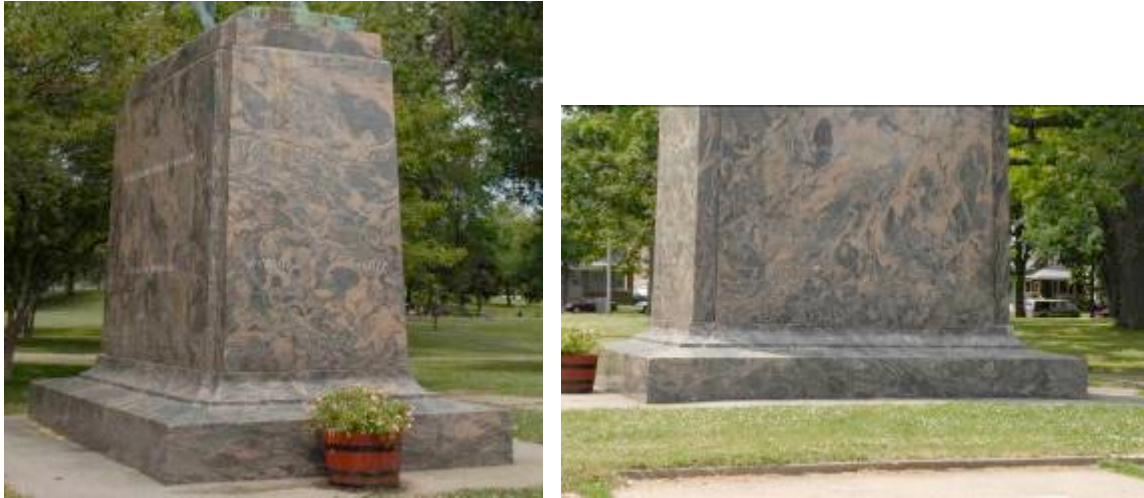
Fig. 17. These two images show both sides of the pedestal. Both sides have an inscription that is difficult to read from a distance.

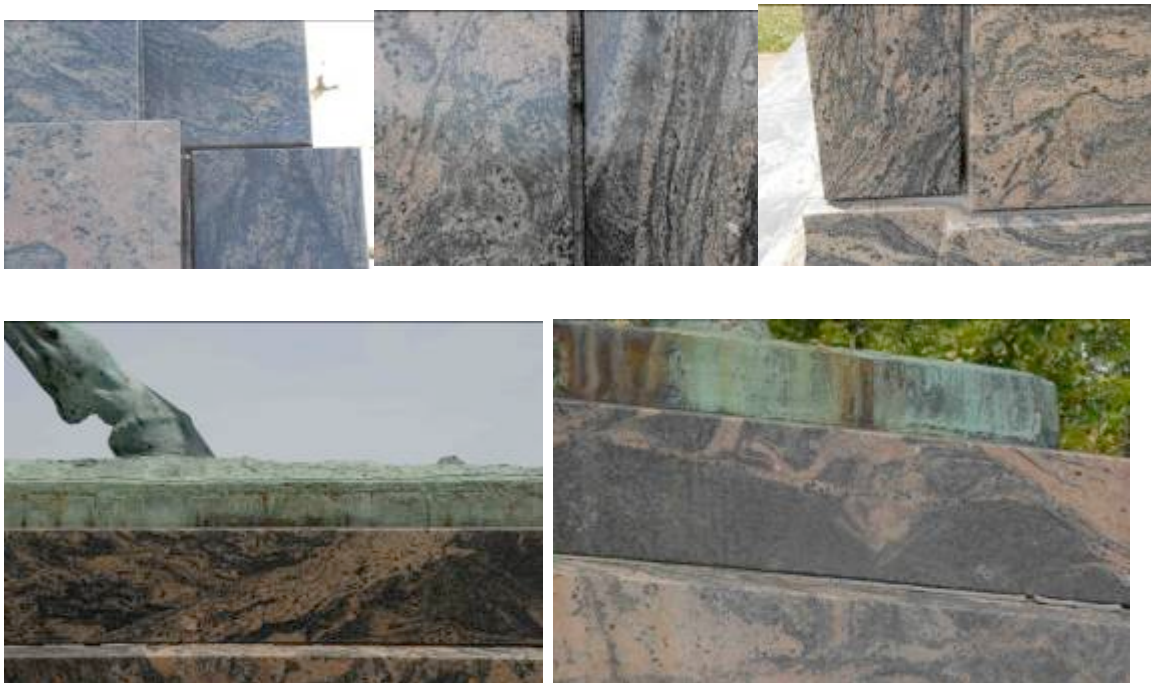
Fig. 18. The above images illustrate deterioration of pointing material. All of the joints of the stone are deteriorated and should be cleaned of old pointing and re-pointed.
