September 13, 2013

Treatment of the Tadeusz Kościuszko Monument

**Gastano Trentanove (Fecit), 1905
Kosciuszko Park, 2201 S 7th St., Milwaukee, WI 53215
Patinated Cast Bronze**

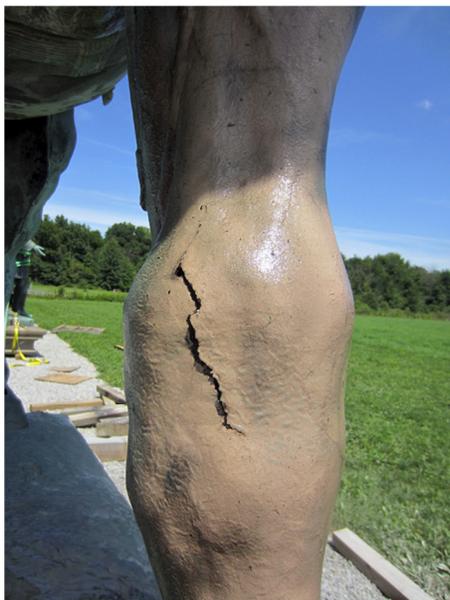
The exterior of the entire artwork work was closely examined and the quality of the casting evaluated. The casting quality was found to be very poor. We have noted the same level of quality in other castings from the Galli foundry in Florence. Large areas of porosity, numerous patches, and chill cracks are evident in many locations of the sculpture. All of the chill cracks had been treated by the original foundry and filled with lead, a common historical method. Almost all are stable with the one exception being the crack at the knee on the proper left leg. This is the site which had been opened and deformed by freeze thaw cycles (CSOS assessment page 7).

The split in the proper left front leg was reformed and welded back together. At this time all of the foundry-installed patches that had been removed for cleaning of the interior were also set and welded into place.

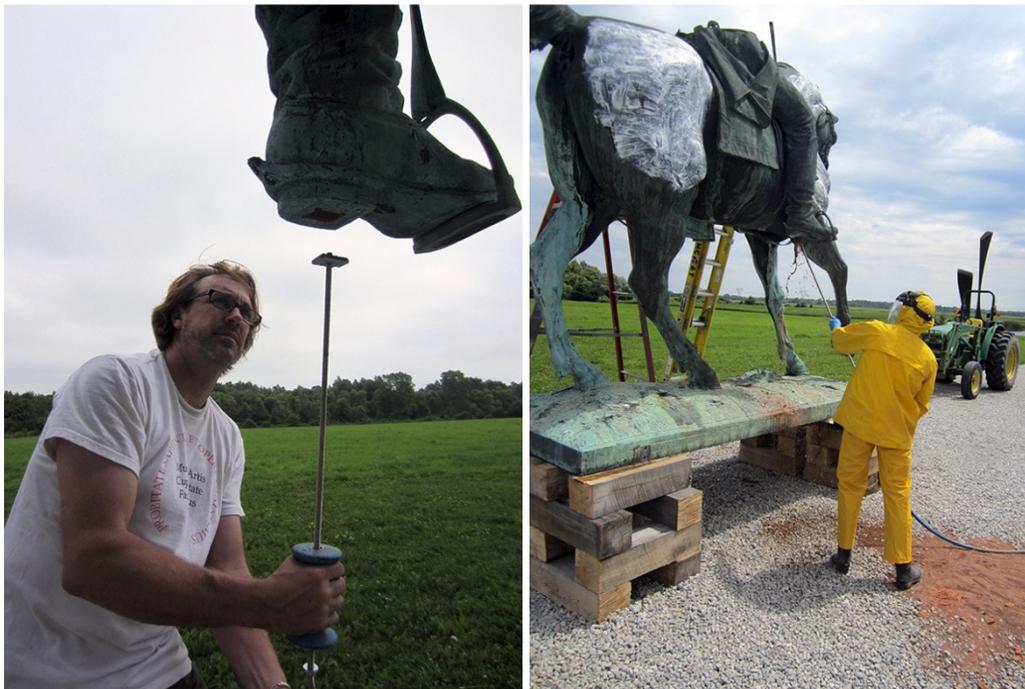
The top portion of the figure was removed at the joint line. This allowed for an inspection of the interior of the artwork. In the condition assessment prepared by CSOS it was stated that the legs of the horse were filled with concrete (CSOS assessment page 10). In fact, the artwork had not been filled with concrete; rather the artwork was full of core material (crushed brick) left behind from the casting process. This material was packed in the interior of the legs and covered 6 inches or so of the interior stomach area of the horse. No concrete was found within the casting.

This core material had to be removed from the sculpture as it can cause the sculpture to fracture or burst when the material saturates with water, freezes and expands. This material can also block the flow of water that must be allowed to escape from the interior of the sculpture to avoid damage caused by freezing.

Particular existing patches were removed to allow complete access to the interior of the legs of the figure and horse. The core material was then removed by high pressure water blasting, leaving the interior of the legs and the entire interior of the horse clean and empty.

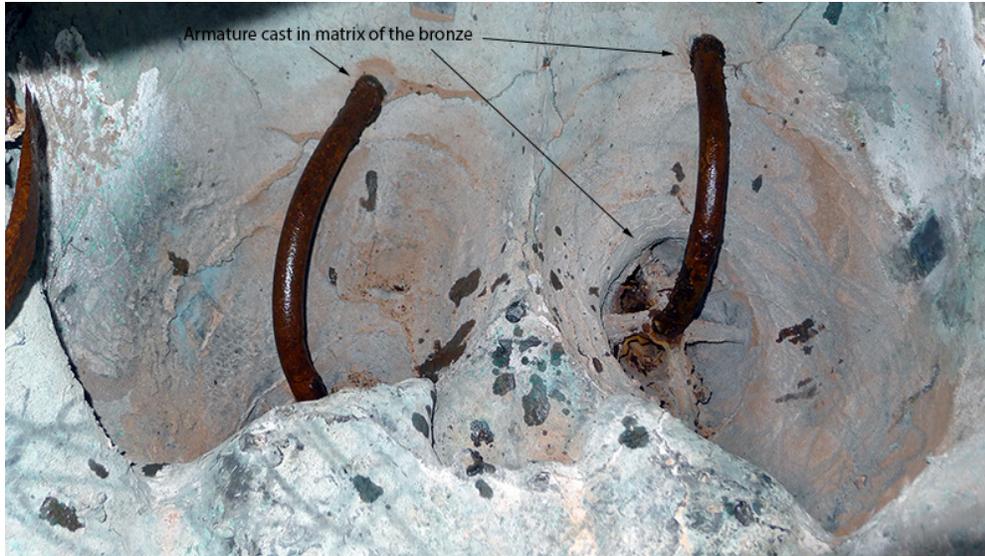
Once clear of core material the internal armature was exposed and closely examined. The armature is made from wrought iron rod approximately 2 inches in diameter. It was found to be in excellent structural condition with only light surface corrosion. The armature was also discovered to be cast in place, trapping it internally within the matrix of the bronze casting. This cast in place method not only provided added support to the bronze but the iron rod was also used as a fastener to attach the legs of the horse to the base of the sculpture.

In the original assessment by CSOS, an assumption was made that the armature had failed and needed replacement. As we discovered, the existing armature was still in place and providing support to the sculpture. Any attempt at removal of the existing armature would be risky as it would require complete removal of the legs and then cutting them into sections to release the armature. Due to the poor quality of casting, any treatment of this nature would prove to be dangerous as there is a high probability of not being able to weld the sculpture back together. Due to these reasons, the existing armature was left in place.

The armature was coated with a very effective rust inhibitor called Ship-2-Shore (Liquid Corrosion Control Systems, LLC, Vancouver, BC) to prevent further corrosion and external staining of the artwork. This corrosion inhibitor hardens into a waxy state and inside the sculpture will provide permanent protection against future corrosion .

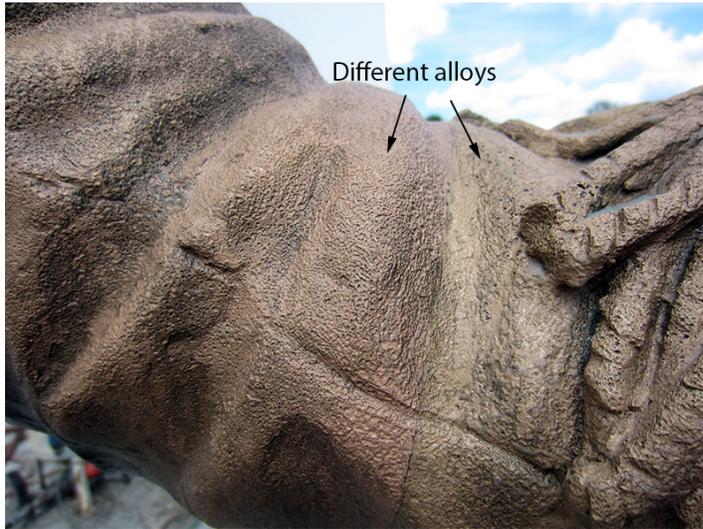
Once cleaned it became evident the sculpture was comprised of differing alloys of bronze. The evidence of this can be seen in color variation between different sections of the sculpture. The reins of the artwork were also discovered to be made of copper.

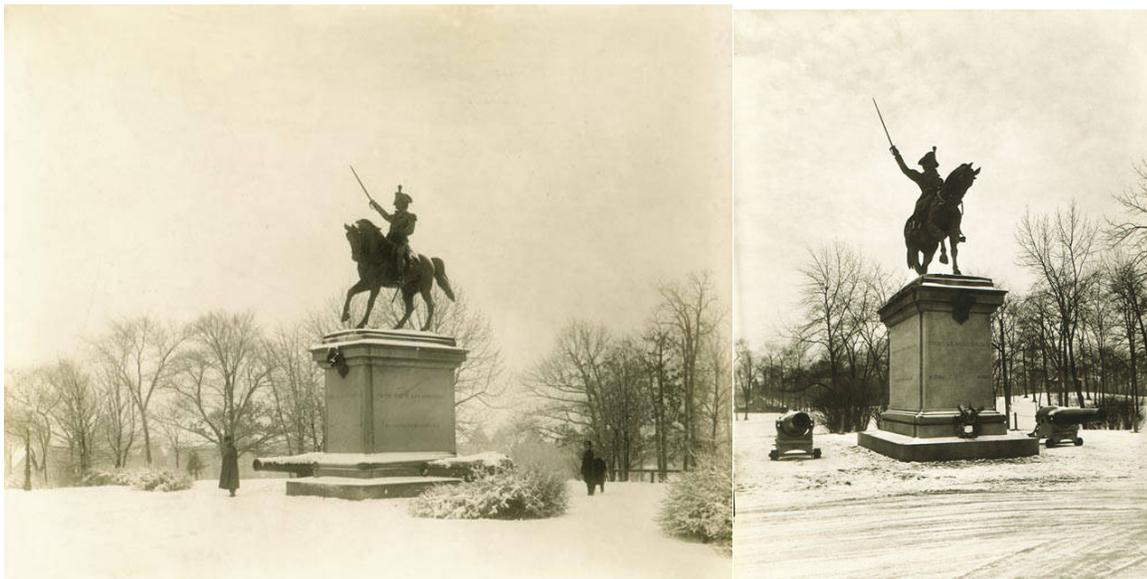
Historically most sculptures of this era were one of two colors, black or what is commonly referred to as "florentine" or statuary brown, with brown being the most common. Early historical photographs of the artwork show the sculpture was lighter in color which is probable evidence of a brown patina.
