September 13, 2013

Treatment of the Tadeusz Kościuszko Monument

**Gastano Trentanove (Fecit), 1905
Kosciuszko Park, 2201 S 7th St., Milwaukee, WI 53215
Patinated Cast Bronze**

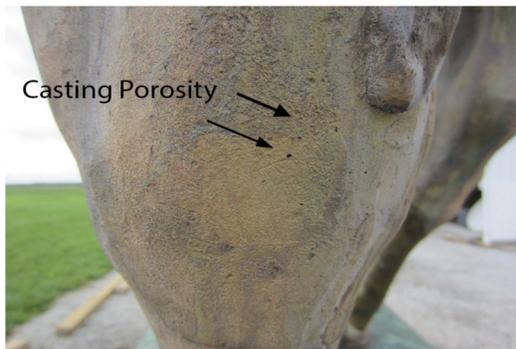
Casting Porosity

The formation of bubbles within the metal during the casting process, this causes a porous or textured surface similar to that of a sponge.

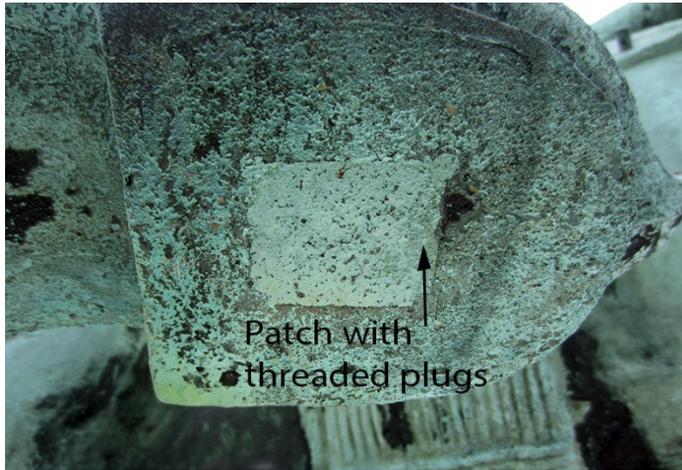
Patches and Plugs

On historical bronze castings smaller voids were drilled out and a threaded plug was made from bronze rod which would be fed into the hole and cut flush with the surface of the bronze. Large voids were often repaired with rectangular patches held in place by threaded plugs.

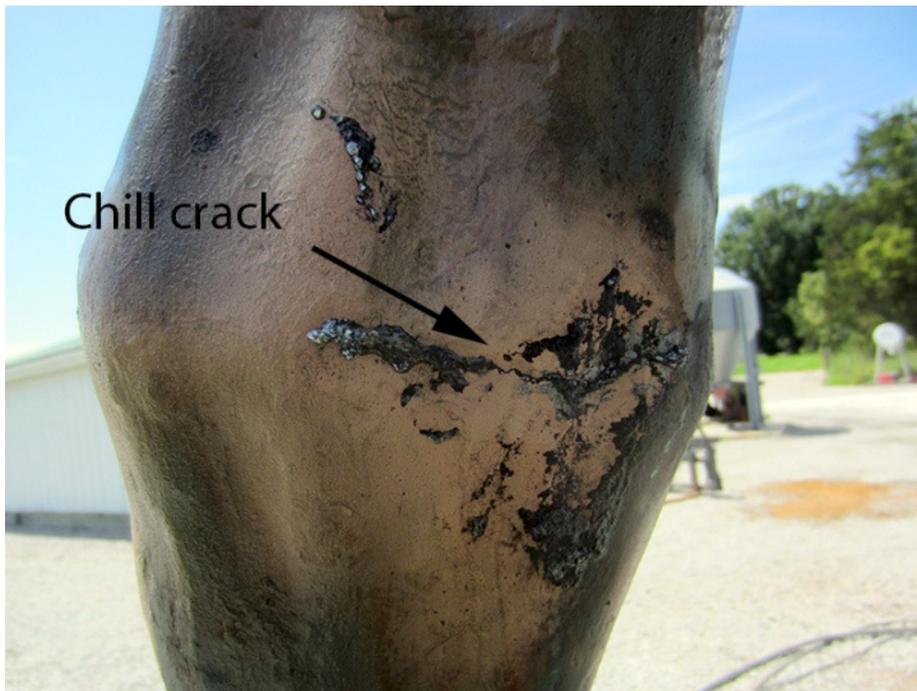
Chill Cracks

Lack of a complete join where two streams of molten metal meet, resulting in a crack, or a weakness. These cracks are typically caused by improper pouring temperature.

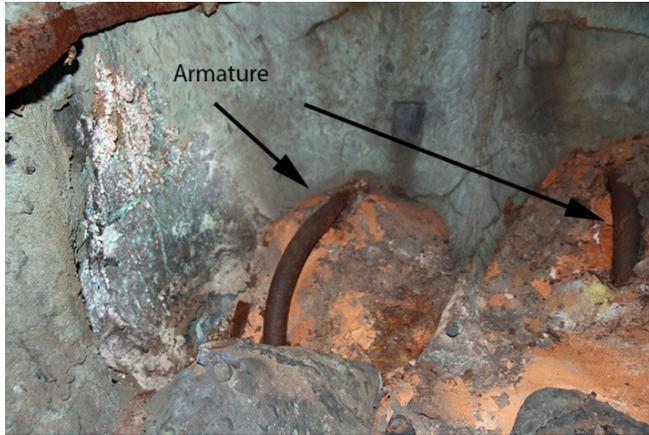
Armature

An internal structure usually made from ferrous metal such as iron or steel. Used in the casting process to provide strength and support for the “core” of the mold.

Once clear of core material the internal armature was exposed and closely examined. The armature is made from wrought iron rod approximately 2 inches in diameter. It was found to be in excellent structural condition with only light surface corrosion. The armature was also discovered to be cast in place, trapping it internally within the matrix of the bronze casting. This cast in place method not only provided added support to the bronze but the iron rod was also used as a fastener to attach the legs of the horse to the base of the sculpture.

The armature was coated with a very effective rust inhibitor called Ship-2-Shore (Liquid Corrosion Control Systems, LLC, Vancouver, BC) to prevent further corrosion and external staining of the artwork. This corrosion inhibitor hardens into a waxy state and inside the sculpture will provide permanent protection against future corrosion .
